Name Of Dam: LAKESIDE

Inventory Number: VA 06920

PHASE I INSPECTION REPORT NATIONAL DAM SAFETY PROGRAM

OCTOBER 1980

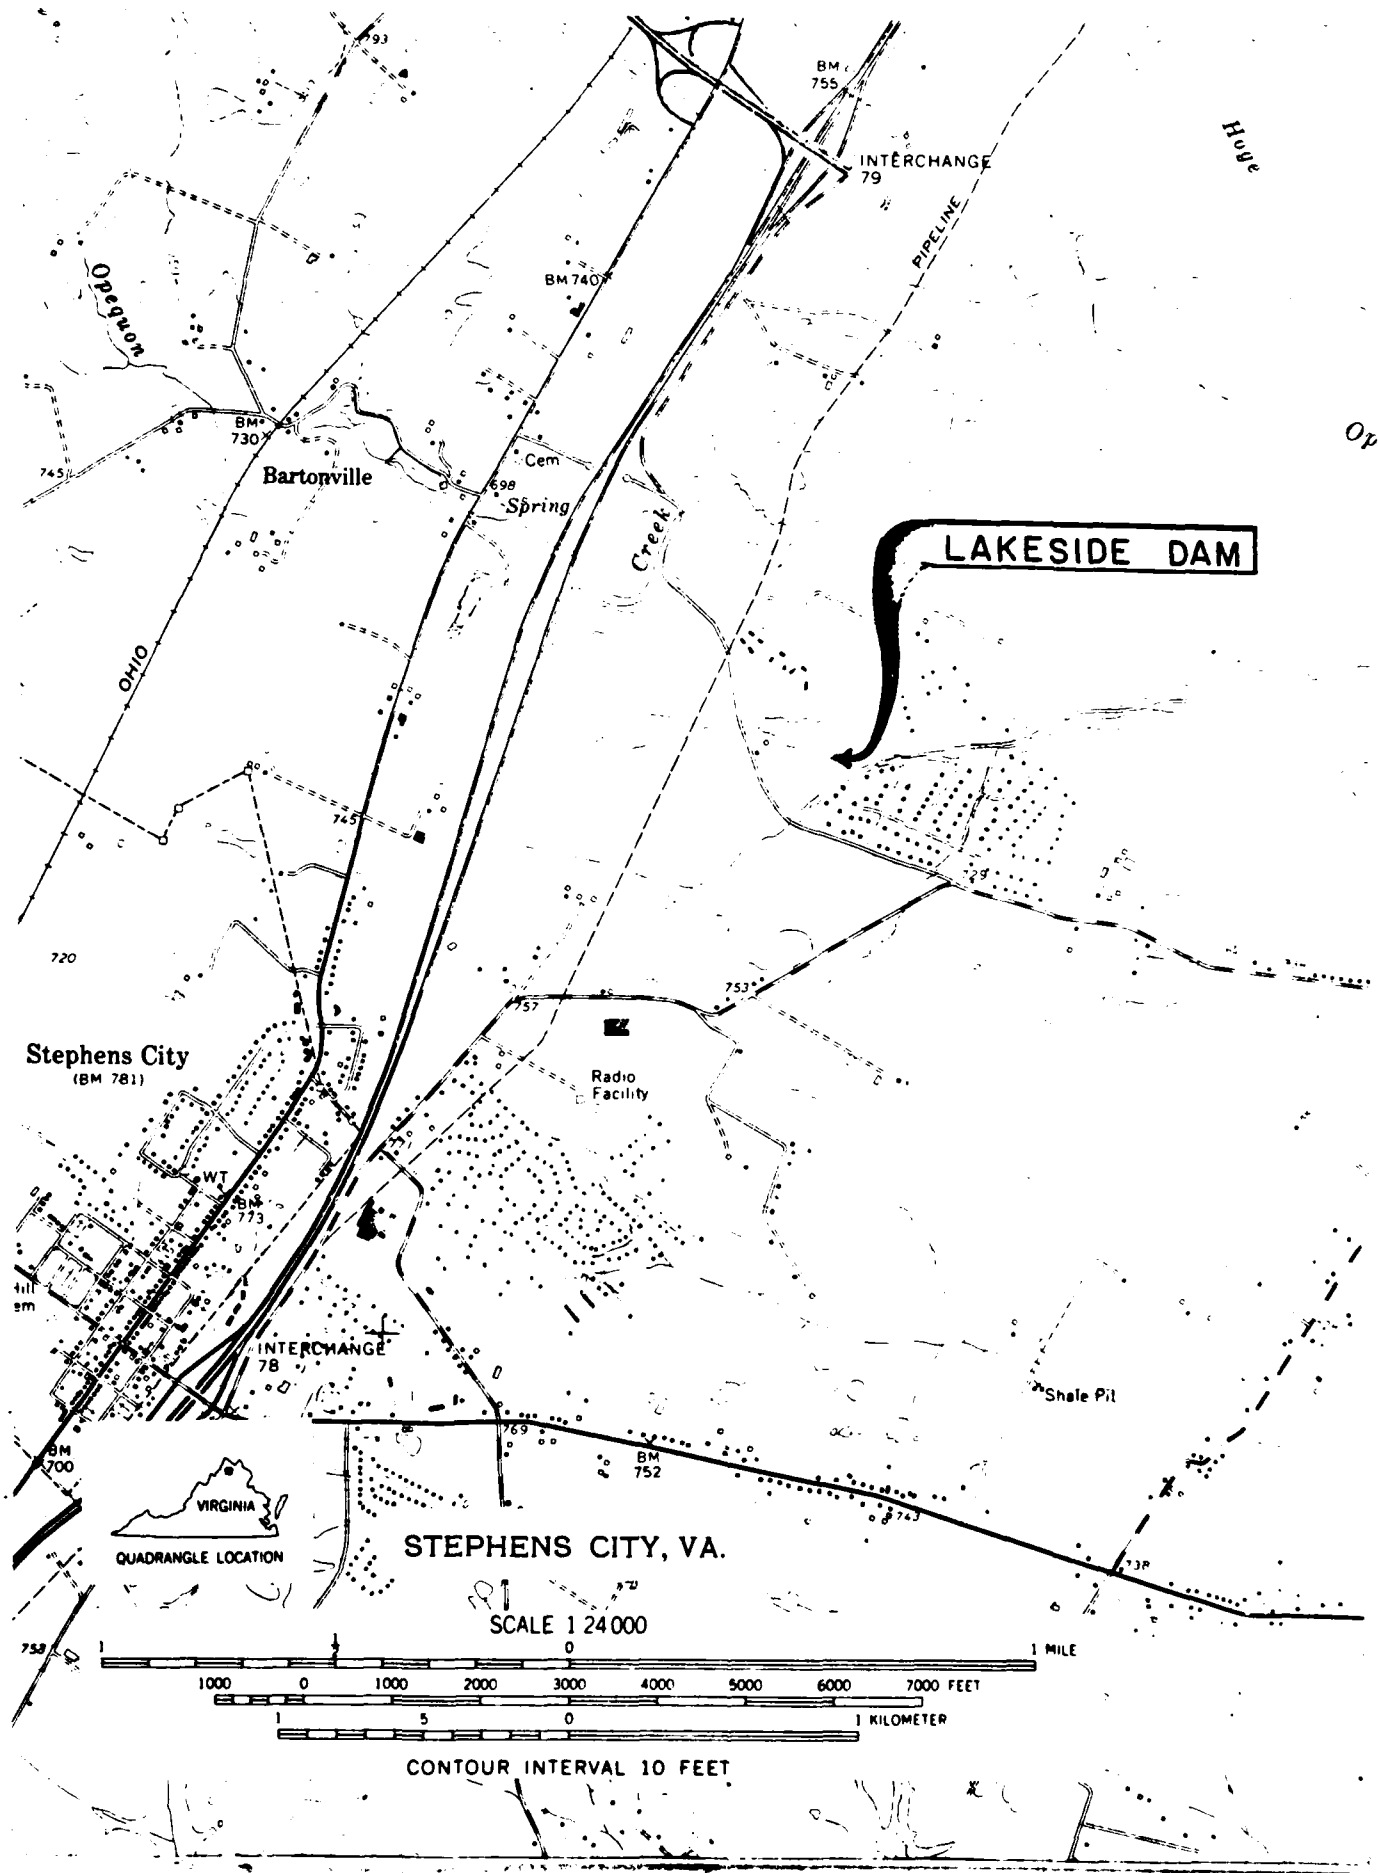
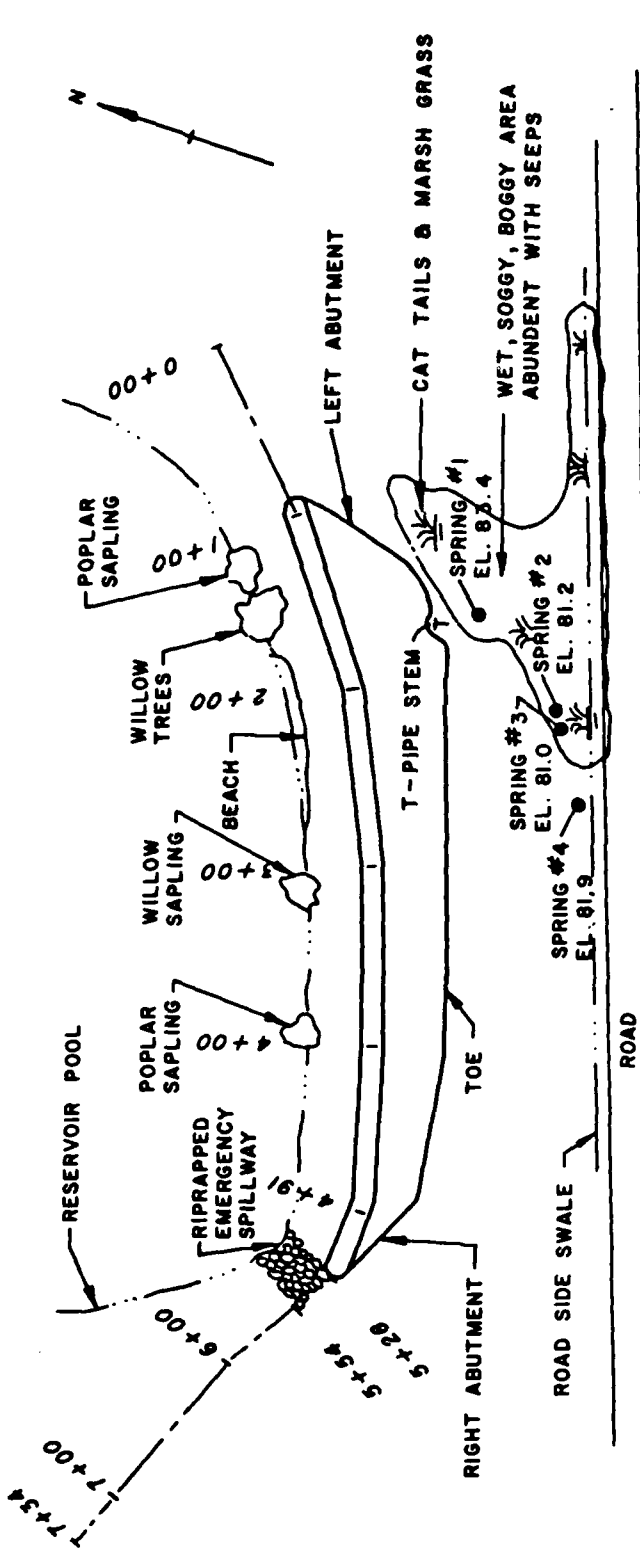
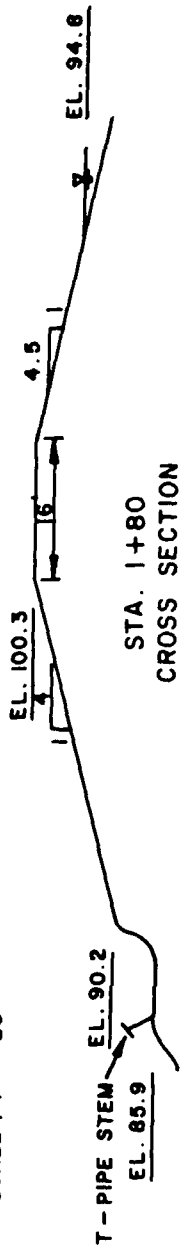
PEZZA
LAKESIDE DAM
FREDERICK CO. VA
29 OCT 80
PLATE 1

3.1.2 Embankment: The embankment is in good condition. A sketch showing a plan view and cross section is provided on Plate I, Appendix I. A crest profile is given on Plate II, Appendix I. Overall views of the crest and downstream face of the dam and of the reservoir area are provided at the beginning of the report.

A marshy area of considerable extent exists beyond the toe of the dam on the lefthand side, and there are several separate seeps or springs evident within or adjacent to this area, as indicated on the plan view. One of these, with a flow estimated to be 1 to 2 gpm, is located a short distance downhill from the "T" pipe valve stem, and may be seepage from the low level drain pipe. This valve stem is reported to have been damaged by a bulldozer working on the site.

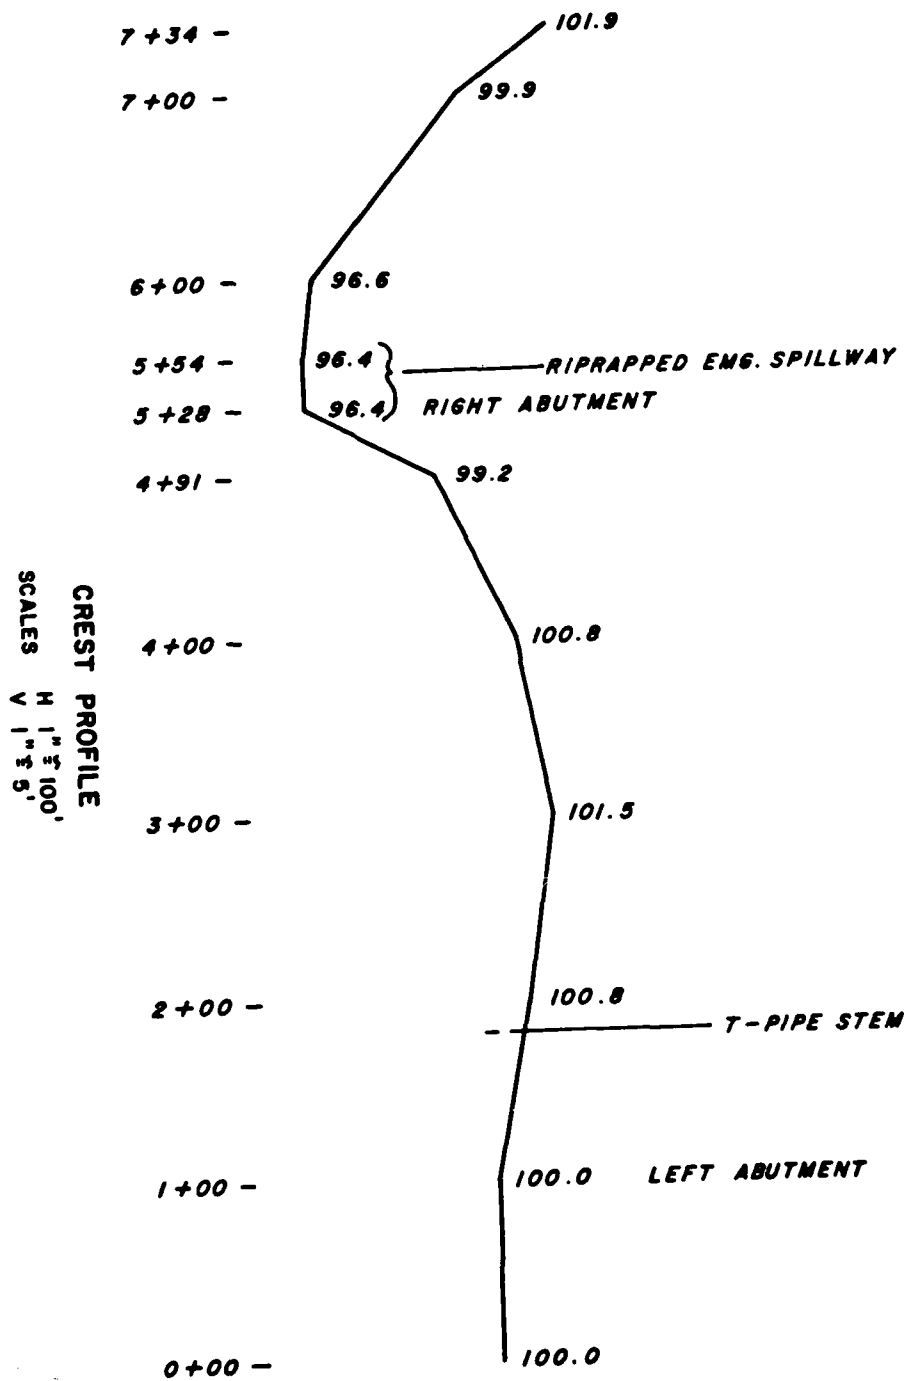
PLATE 2

NOTE: 1. ROAD IN RESERVOIR AREA @ 103.3.
PIPE INVERT @ 97.8

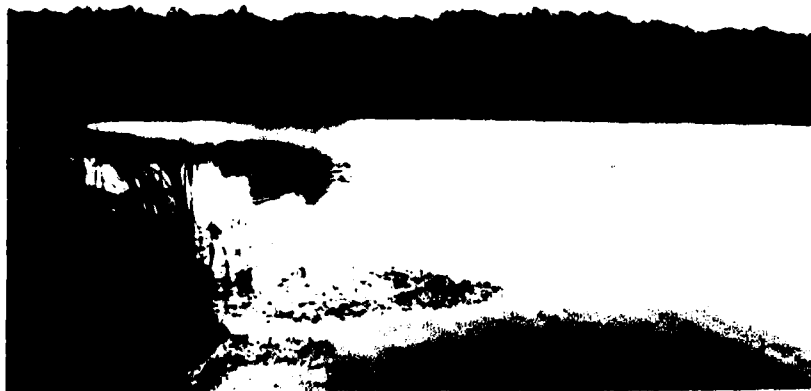
There are no signs of surface cracks, unusual movement, sloughing, or misalignment. Wave erosion is forming a bench on the upstream face of the dam, particularly in the area free of shoreline vegetation. The crest of the dam has some tire ruts and there is a trail bike path on the left downstream face of the dam. The riprap has failed in the area of the wave erosion bench, and elsewhere has deteriorated.

There are scattered poplar and willow saplings and trees on the upstream face of the dam, and some light brush. There are no known foundation drains.

PHOTO # 2 UPSTREAM FACE (IN FOREGROUND)

c. All trees and saplings less than three inches in diameter on the upstream face of the dam should be cut even with the ground to prevent the eventual deterioration of the dam by root systems. All trees greater than three inches in diameter should be removed along with the root system. The subsequent hole should be filled with well compacted material and seeded or sodded.

d. Place compacted fill in the area of the upstream face eroded by wave action, reseed, and protect with riprap at the wave line area.

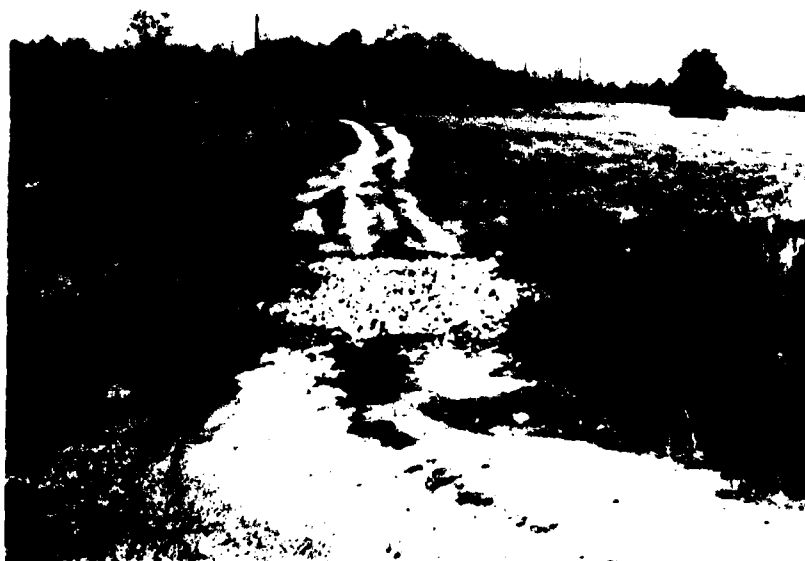
PHOTO *6 THE SPILLWAY (STONE LINED)
